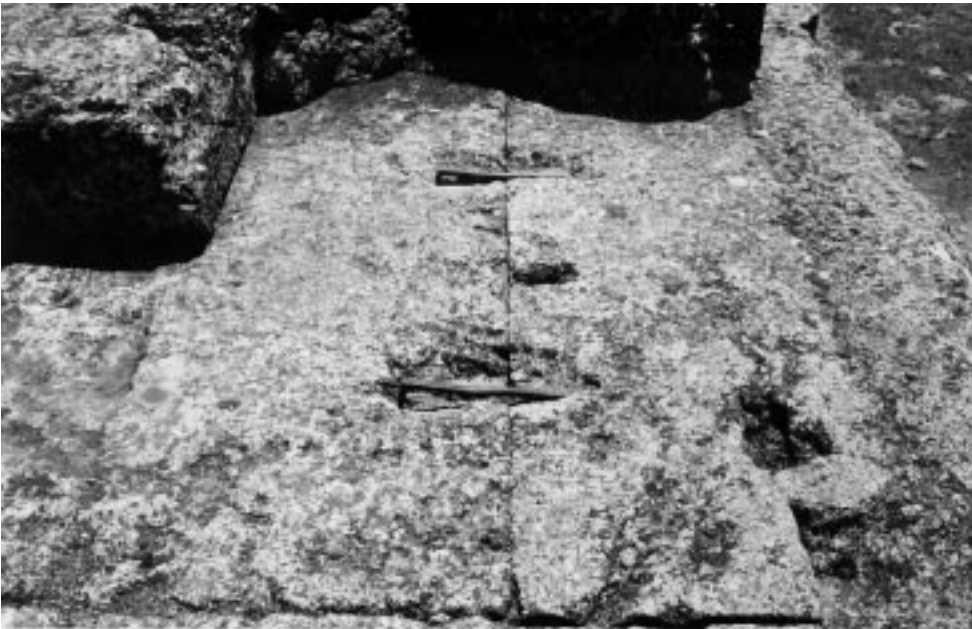
were removed. The process is visible in two rare examples where the clamps were being pried out when something interrupted their removal (Fig. 12).

Fig. 12. Two ancient iron clamps partially pulled from their blocks.

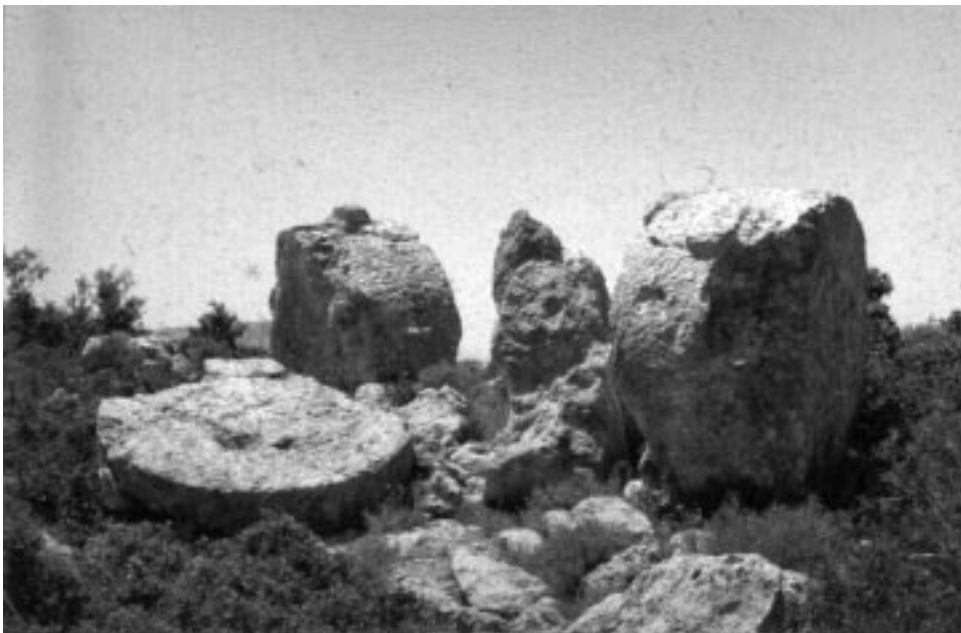
The stone of the Temple of Nemean Zeus came from quarries lying 3 kilometers to the east where roughly worked column drums—prepared but never moved to the temple or used (Fig. 13)—still lie. The stone is a sandy limestone with pockets of “rotten” stone or even earth interspersed with areas of very hard stone. This is the stone which we must cut and use to replace the blocks robbed out of the base of the temple centuries ago.

Fig. 13. Rough worked column drums still in the quarries.

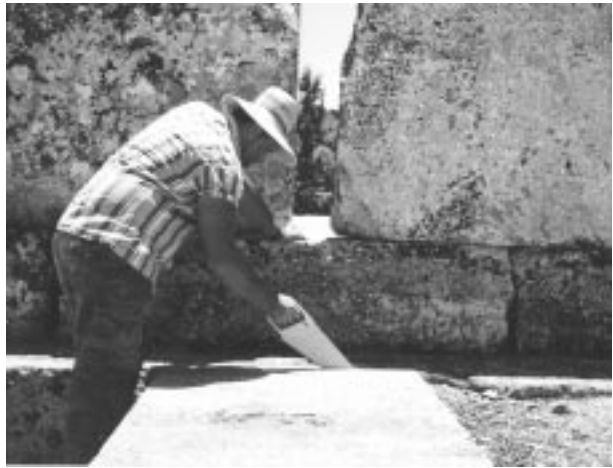
order to create precisely conforming surfaces—if the saw went a little more deeply into the surface of one block, it automatically left a corresponding convex bulge in the surface of the adjoining block (Fig. 14). The surfaces were not necessarily perfectly straight, but they were perfectly parallel. Not only did this use of the saw solve our problems, but it forced us to look at ancient joint surfaces where we discovered that there are still clear traces of saw marks from antiquity (Fig. 15). The local workmen were proud that they had discovered one of the secrets of their ancestors, and became convinced

Fig. 14. Sawing a joint.

that the saw was the tool of choice on our sandy limestone, including even the creation of the horizontal joints between column drums. Again, the workmen were correct for the ancient surfaces show the long and curving lines left by the saw. And again, I await a graduate student to do a dissertation on the use of the saw in ancient stone masonry.

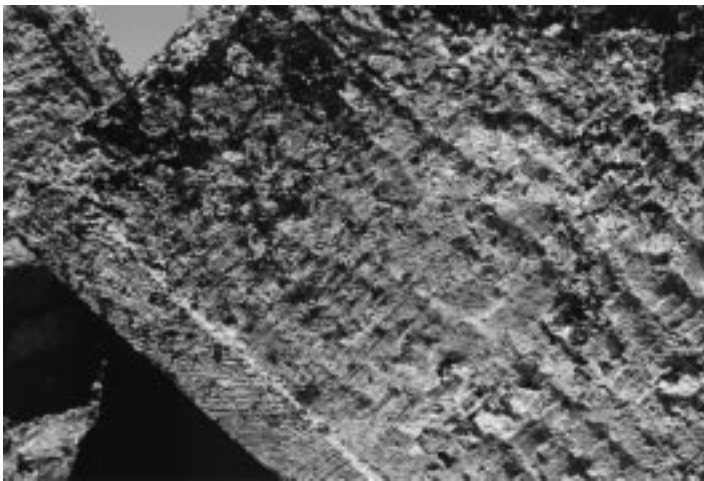
Figure 15: Saw marks on narrow joint surface of epistyle block contrasted with chisel marks on recessed, non-joint (anathyrosis) surface to the right.

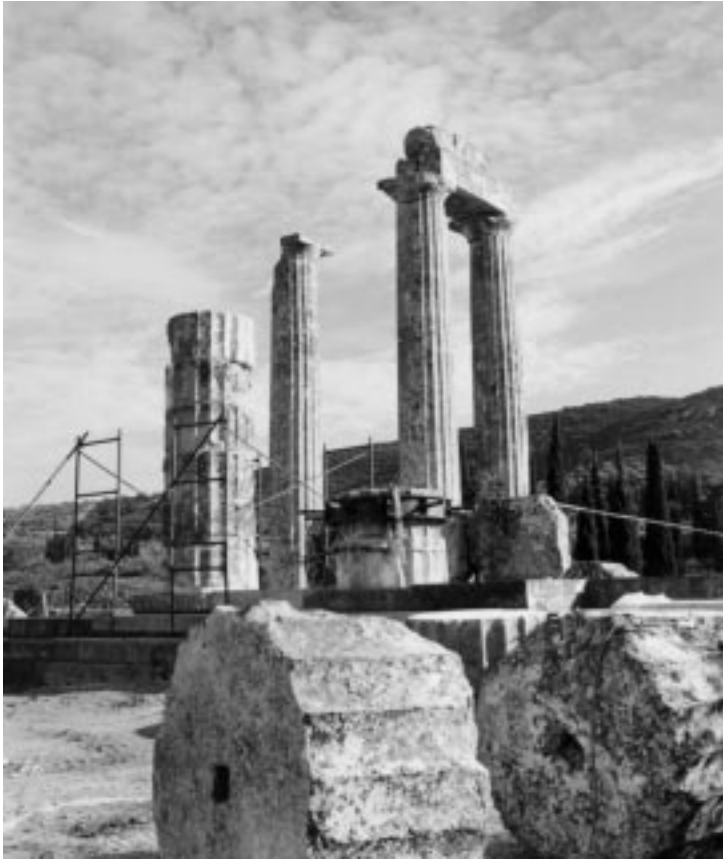
The Temple of Nemean Zeus is a laboratory and a classroom where we learn and share our newly rediscovered knowledge. We are returning to that classroom thanks to the generosity of an Athenian businessman, Theodore Papalexopoulos, who has provided the funds to re-erect those two columns that were planned already fifteen years ago. At the end of November 1999, they were growing (Fig. 16) and are now more than half done. Our hopes do not stop there, however. It is

Fig. 16. Two “new” columns going back in place (six drums set on one, two on other, of total 13 in each) on November 29, 1999.
